April 28, 1997

Subject: Site Inspection Report, Johns-Manville Coalinga Mill Area Site,  
Fresno County, California

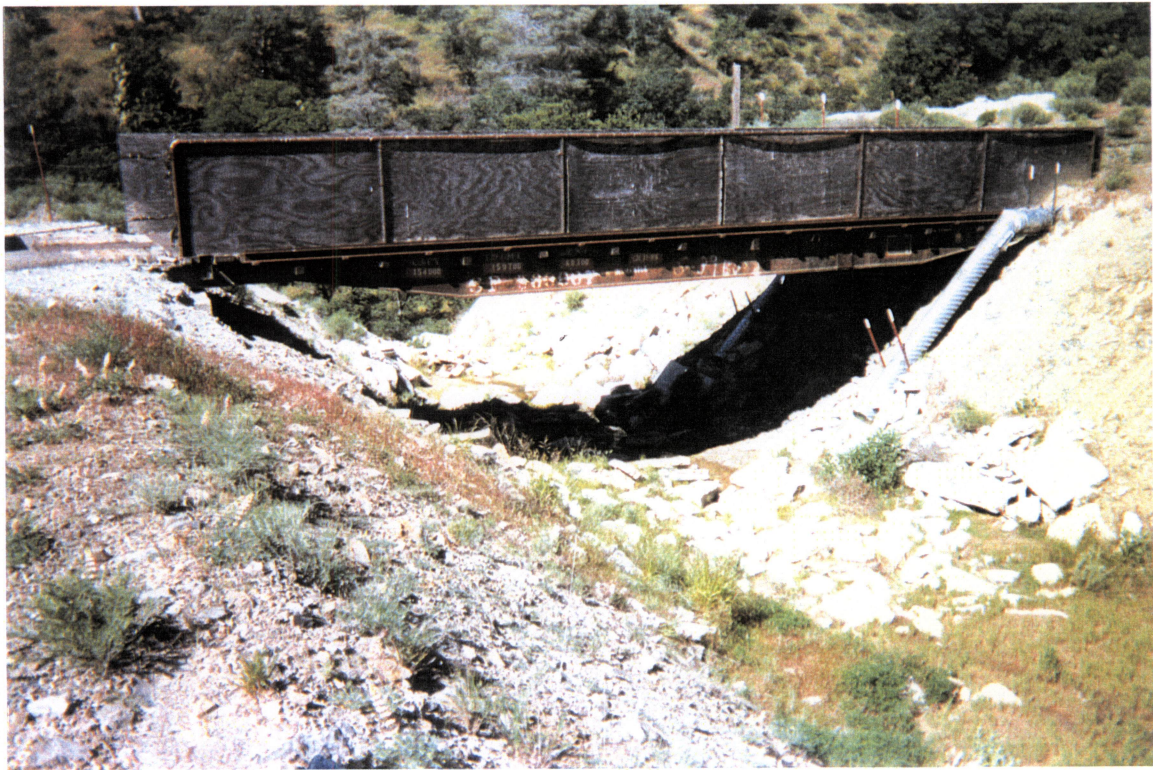
**VEGETATION NEAR BRIDGE**

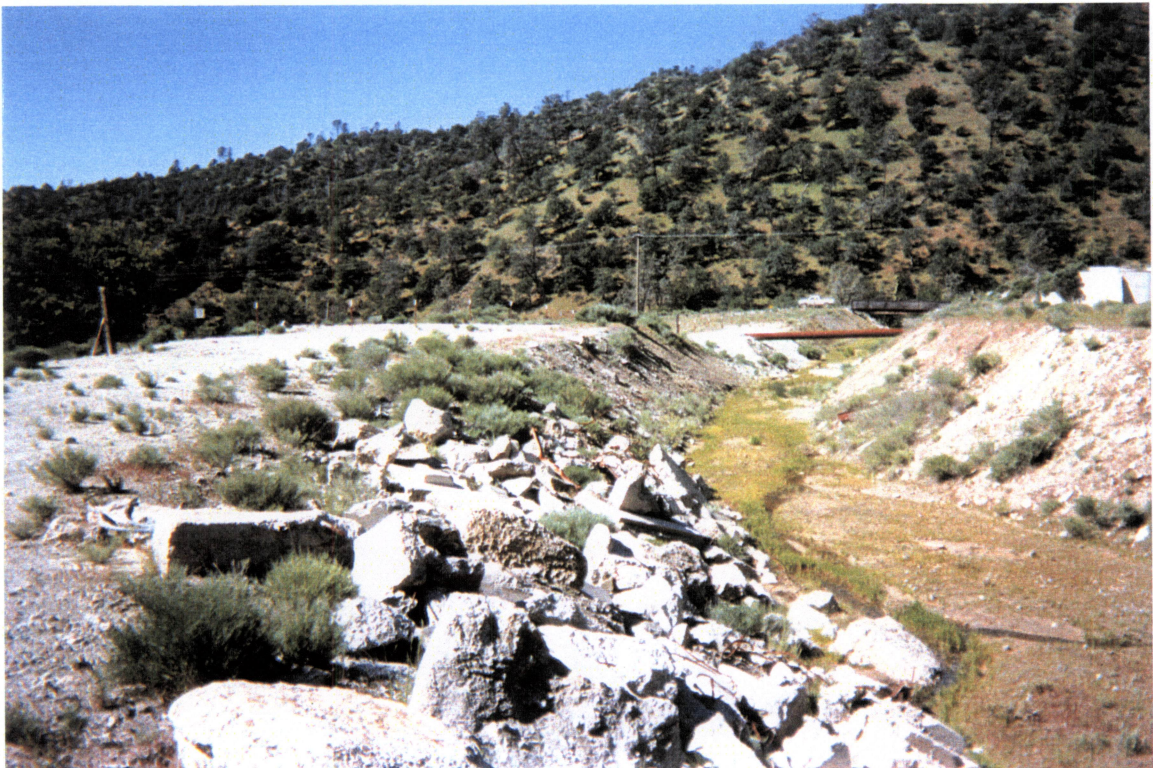
**EAST END OF DIVERSION CHANNEL**

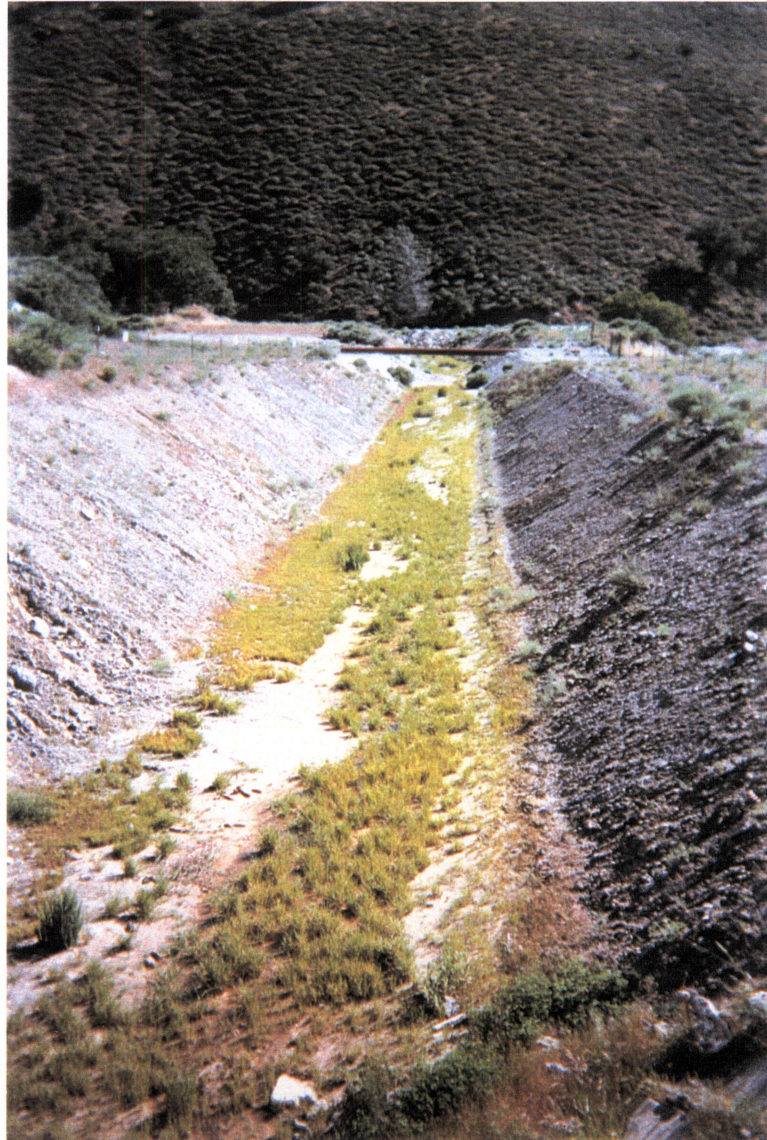
**DIVERSION CHANNEL LOOKIN EAST**

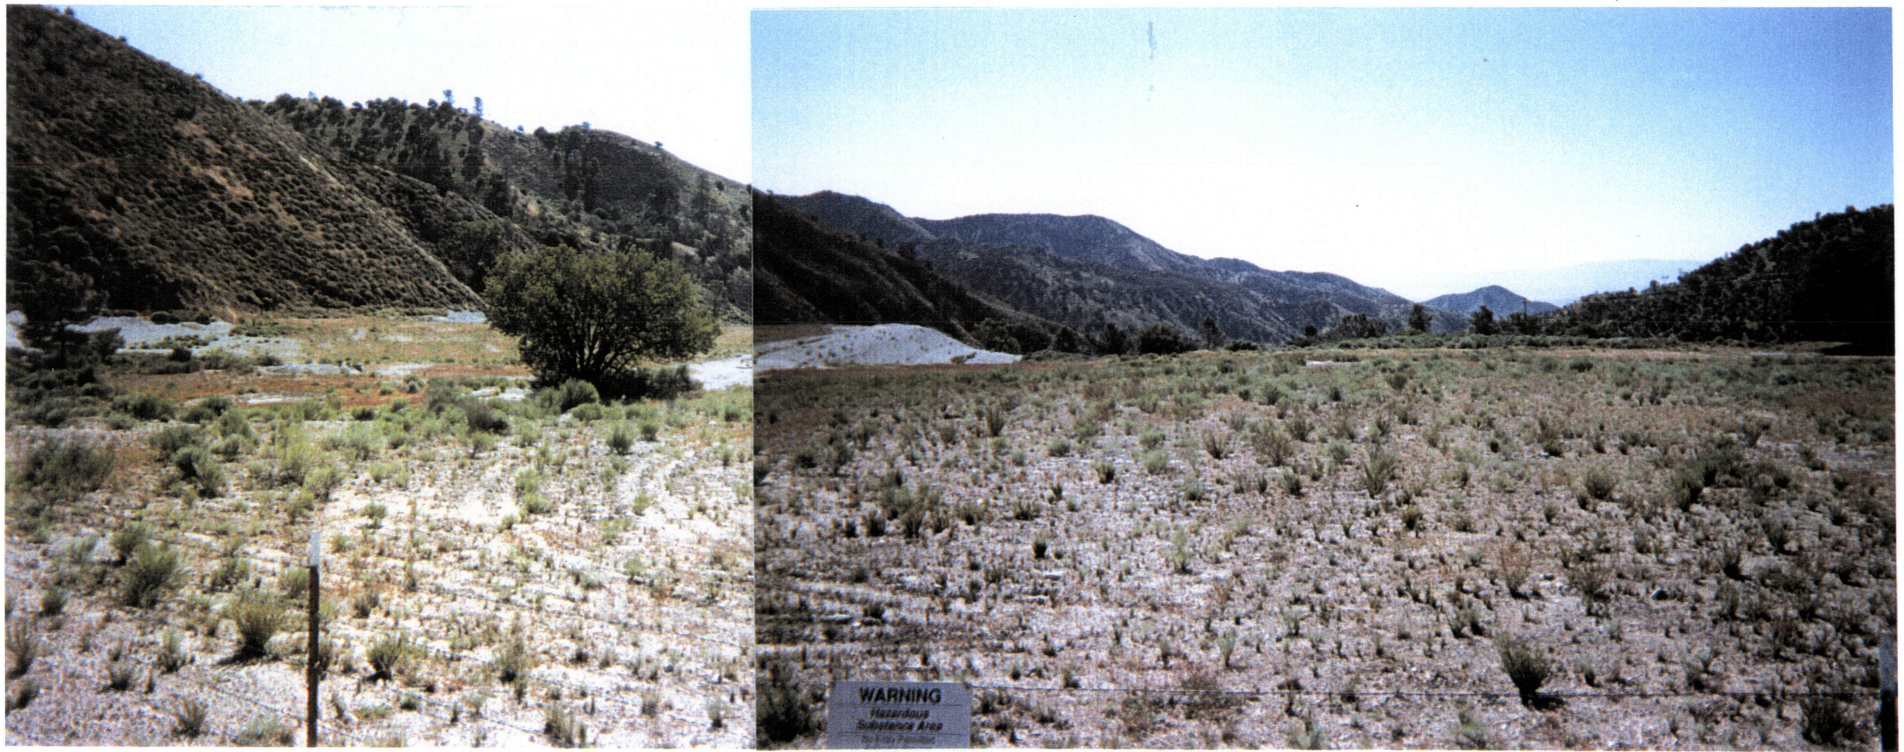
**FORMER MILL AREA LOOKING SOUTH**

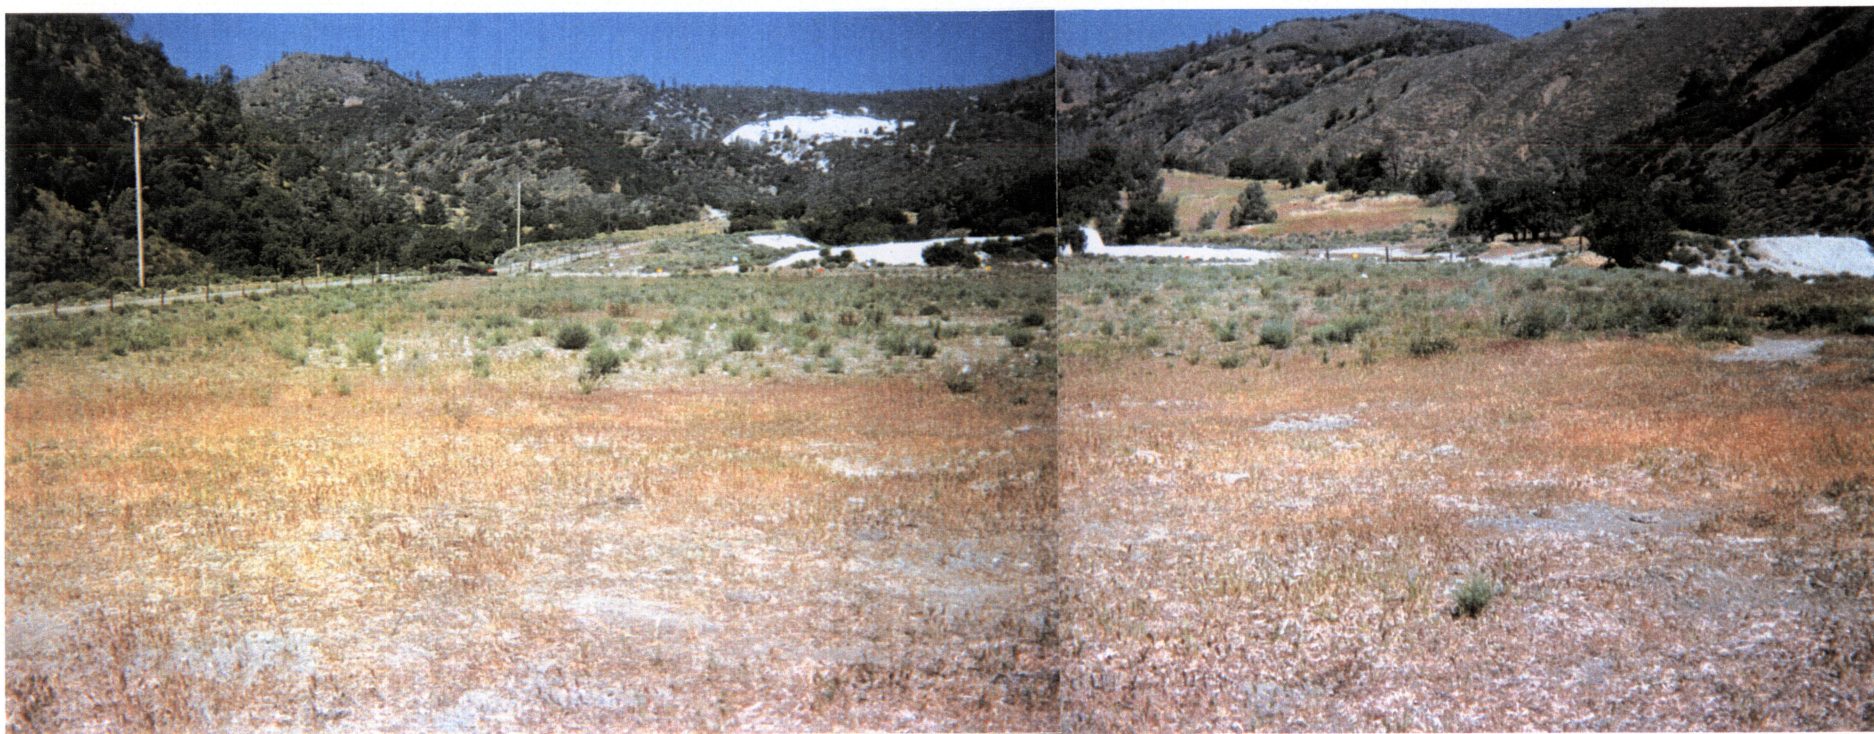
**FORMER MILL AREA LOOKING NORTH**

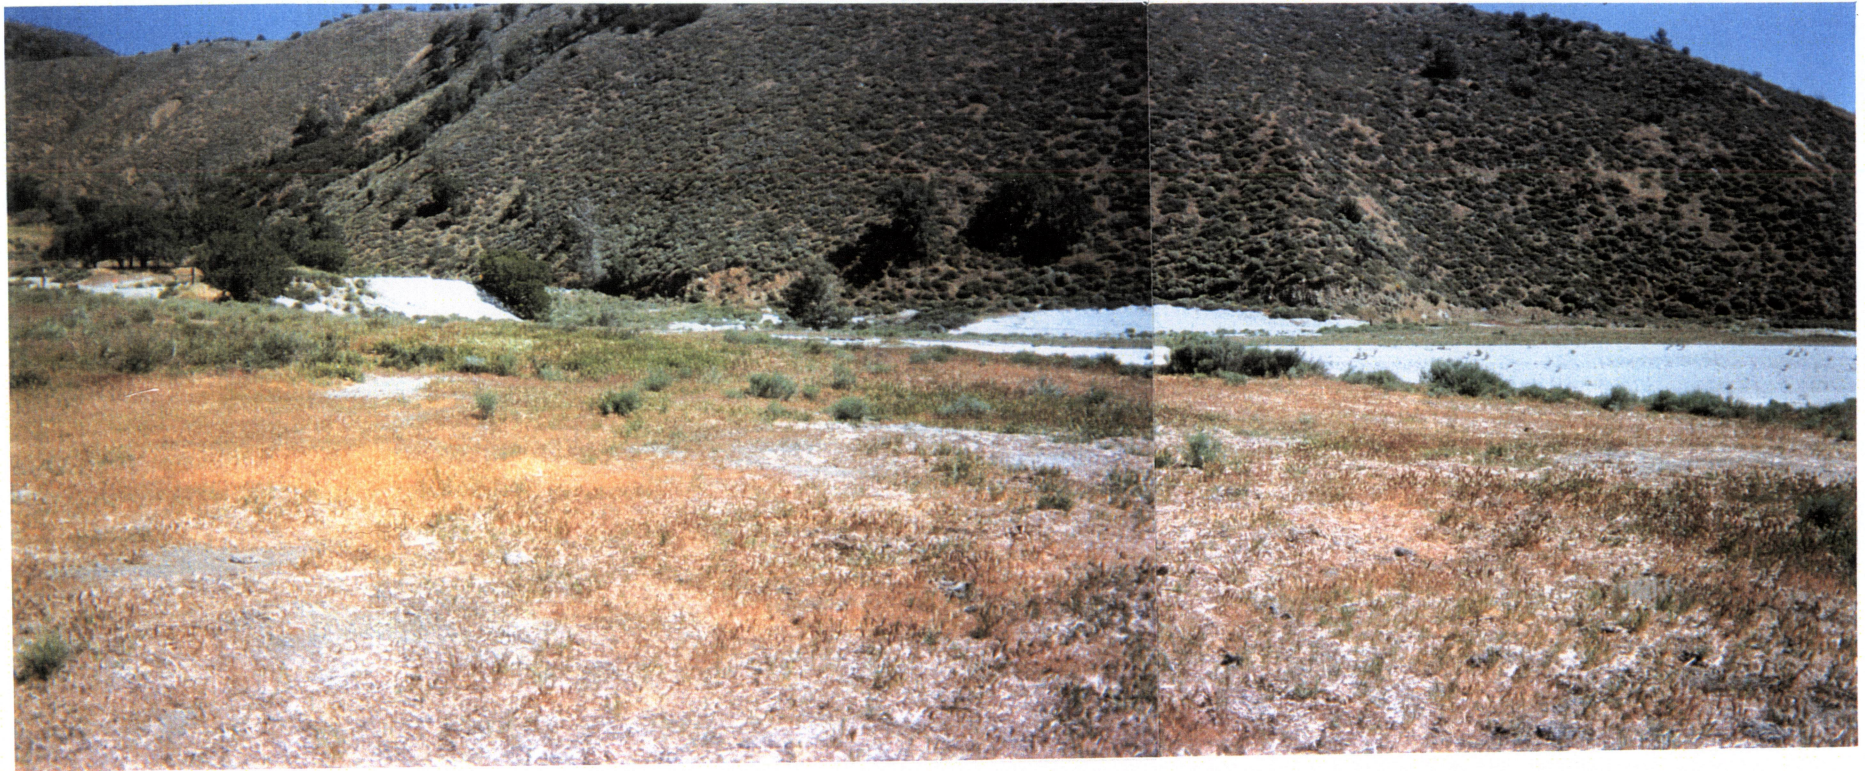
**FORMER MILL AREA LOOKING EAST**

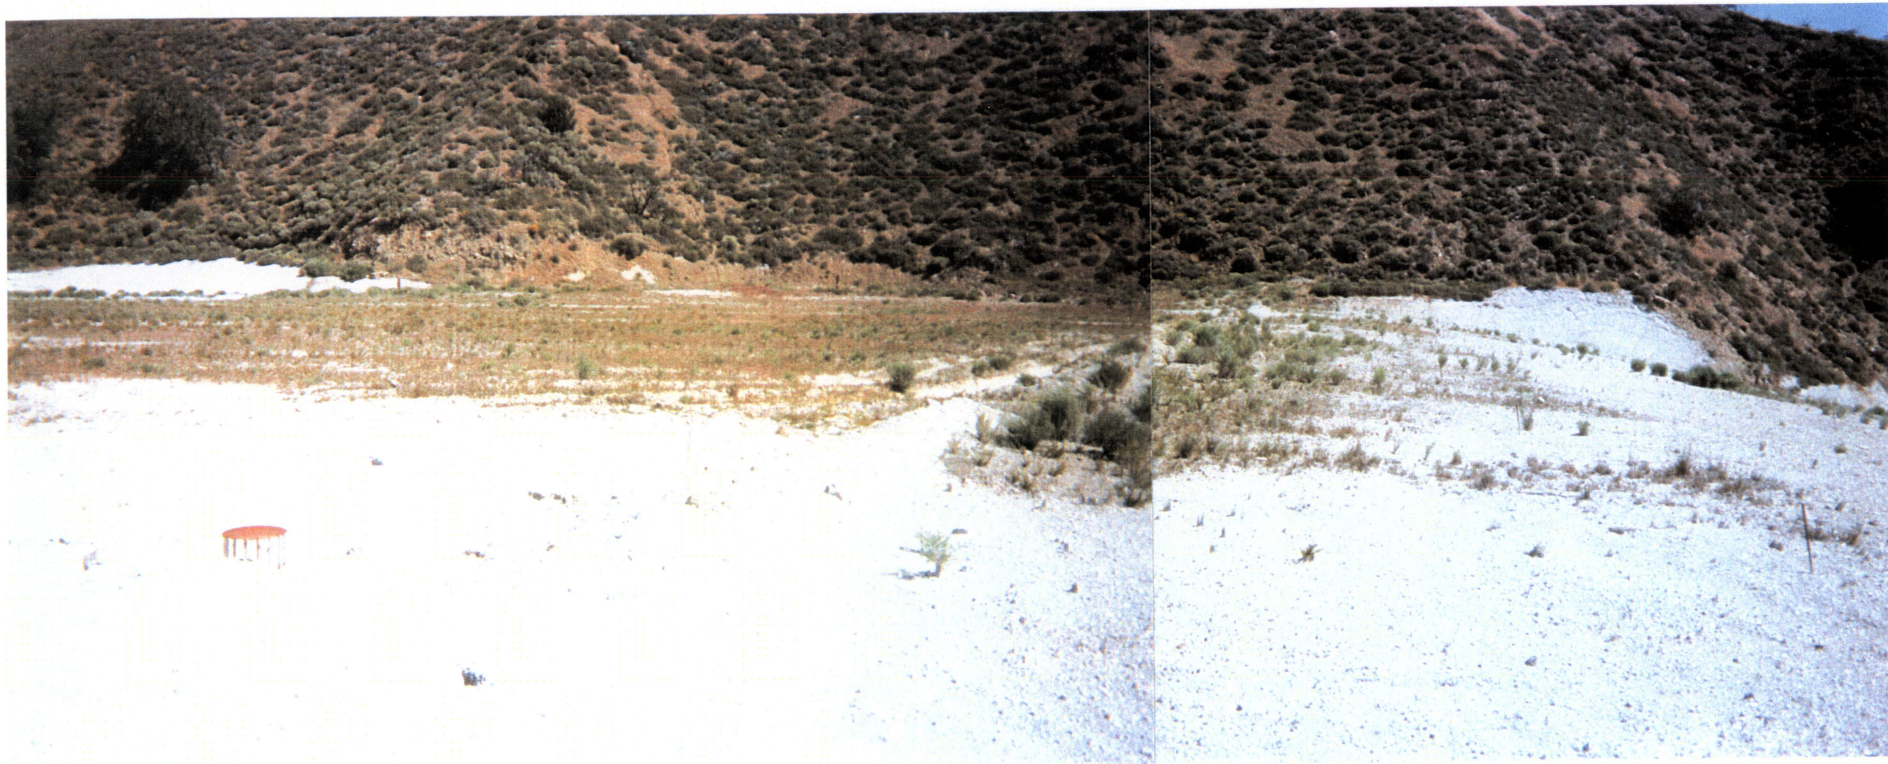
**UPPER SLOPE OF TAILINGS PILE**
